FIRE RISK ASSESSMENT REPORT
on behalf of Colchester Borough Homes

1-4 Tynedale Square
Colchester
CO4 9SN

Date assessed: 12th September 2022

Project Number: 85282

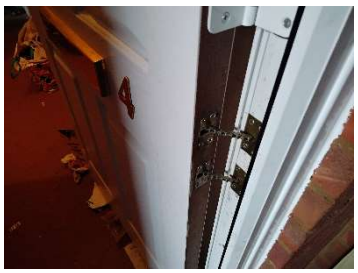
Hazard: Measures to Limit Fire Spread and Development	Priority: Medium
Issue Ref: ES/85282/008

Significant Findings: Flat entrance doors/frames are replacement composite fire doors (N.B. - From limited visual inspection of flat 4 or as no flats were inspected; certification not seen; adequacy of installation not confirmed).	
Action Required: As flat entrances have been fitted with composite door sets, these should have test evidence demonstrating they meet the performance requirement in Building Regulations guidance for fire resistance and smoke control from both sides. Management should confirm that suitable fire door test certificates are held and that these relate to the doors fitted. If adequacy cannot be confirmed it may be necessary for door sets to be replaced under a risk-based programme.	
Actioned by:	**Date of Action:**
Comments Following Action:

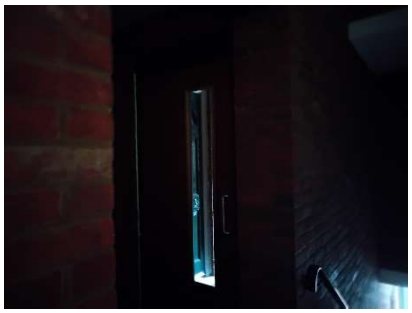
Hazard: Means of Escape	Priority: Medium
Issue Ref: ES/85282/005	
Significant Findings: Lighting levels near flats 2 & 3 is very poor.	
Action Required: Management to confirm lighting levels are acceptable to provide safe means of escape.	
Actioned by:	**Date of Action:**
Comments Following Action:

Hazard: Fire Safety Signs and Notices	Priority: Low
Issue Ref: ES/85282/006	
Significant Findings: No signage on thumb turn lock to exit building.	
Action Required: Signage to be placed above thumb turn to denote which way lock releases.	
Actioned by:	**Date of Action:**
Comments Following Action:

Thumb turn lock available to release lock.	
Lighting levels poor on first floor landing from stairs leading to flats 2 & 3.

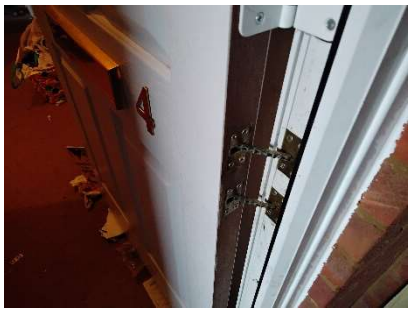
Flat entrance doors/frames are replacement composite fire doors (N.B. - From limited visual inspection as no flats were inspected; certification not seen; adequacy of installation not confirmed).

Meter cupboards are present within the communal area for each flat. Upon inspection of the meter cupboards the assessor found that cables have not been fire stopped as they enter into the cavity. A fire in these cupboards could spread into the cavity.

Cable within the electrical cupboard located on ground floor breaching the wall.

Flat doors composite material but no certification available of flat 4 door.

Cables within electrical cupboard breaching hole in wall.	
Meter cupboards are present within the communal area for each flat.	
Electrical riser cupboard located through door at side of block is not suitable to prevent fire/smoke spread for a minimum of 30 minutes.
