# FIRE RISK ASSESSMENT REPORT
# on behalf of Colchester Borough Homes

# 6-8 Tynedale Square
# Colchester
# CO4 9SN

**Date assessed: 12th September 2022**

**Project Number: 85283**

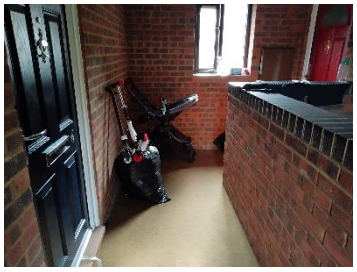
| **Hazard: Housekeeping** | **Priority: Medium** |
|---|---|
| ***Issue Ref:*** ES/85283/008 | |

| **Hazard: Housekeeping** | **Priority: Medium** |
|---|---|
| **Significant Findings:** There were combustible items and trip hazards in the escape routes. | |

| **HOUSEKEEPING** | |
|---|---|
| Combustible items and trip hazards in the escape routes. | |

| **Hazard: Housekeeping** | **Priority: Medium** |
|---|---|
| **Action Required:** Management should contact residents to advise that the common area/escape routes should be kept free from all combustibles and/or trip hazards. A programme of regular checks should be put in place to ensure that the common area is kept clear. | |
