FIRE RISK ASSESSMENT REPORT
on behalf of Colchester Borough Homes

1-6-Wheeler Close
Colchester
CO4 3YT

Date assessed: 8th February 2023

Project Number: 87176

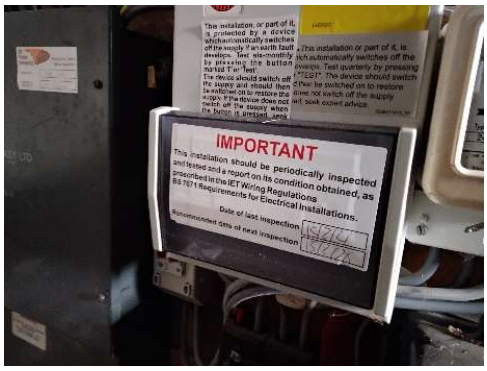
A system testing label dated was fitted to the Main Circuit Board.

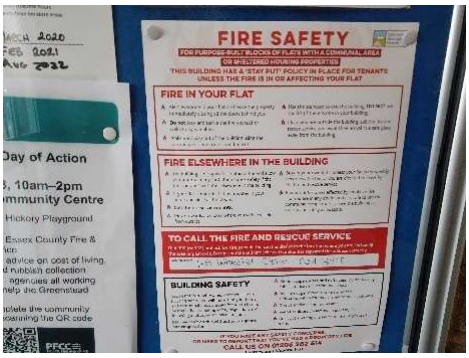
Keep Locked Shut signage on all appropriate doors including entry doors.	
Keep Locked Shut and Danger Electricity signage on electrical intake cupboard.	
The current evacuation strategy is Stay Put as denoted by the fire action notices displayed in the common area.

No smoking signage displayed on entry to the common areas.
