FIRE RISK ASSESSMENT REPORT
on behalf of Colchester Borough Homes

15-18 Wilkins Court
Colchester
CO3 4TE

Date assessed: 11th October 2022

Project Number: 85718

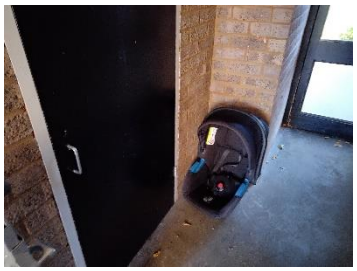
Hazard: Housekeeping	**Priority: Low**
Issue Ref: ES/85718/006

Significant Findings: There were combustible items and trip hazards in the escape routes.	
Action Required: Management should contact residents to advise that the common area/escape routes should be kept free from all combustibles and/or trip hazards. A programme of regular checks should be put in place to ensure that the common area is kept clear.	
Actioned by:	**Date of Action:**
Comments Following Action:

There were combustible items and trip hazards in the escape routes.
