FIRE RISK ASSESSMENT REPORT
on behalf of Colchester Borough Homes

2-3 William Sparrow Court
Colchester
CO7 9EQ

Project Number: 85291

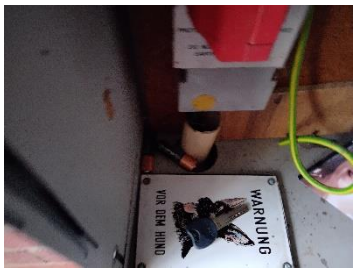
Hazard: Measures to Limit Fire Spread and Development	**Priority: Medium**
Issue Ref: ES/85291/009

Significant Findings: Meter cupboards are present within the communal area for each flat. Upon inspection of the meter cupboards the assessor found that cables have not been fire stopped as they enter into the cavity. A fire in these cupboards could spread into the cavity.	
Action Required: The meter cupboards should be fire stopped by a competent contractor using suitable fire resisting materials that conform to BS 476 and achieve a minimum of thirty minutes of fire resistance.	
Actioned by:	**Date of Action:**
Comments Following Action:

Meter cupboards are present within the communal area for each flat. Upon inspection of the meter cupboards the assessor found that cables have not been fire stopped as they enter into the cavity. A fire in these cupboards could spread into the cavity.
