FIRE RISK ASSESSMENT REPORT
on behalf of Colchester Borough Homes

1-4 Willingham Way
Colchester
CO4 3YG

Date assessed: 7th March 2023

Project Number: 86914

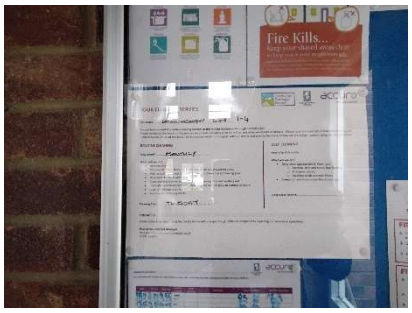
Housekeeping is of a good standard within the property and cleaning undertaken regularly, including rota displayed on notice board.

Refuse area	
Cleaning rota

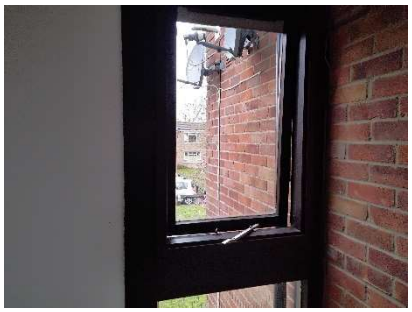
There are openable windows on each floor that could be used by the fire service to vent smoke in the event of a fire.

Openable window on first floor

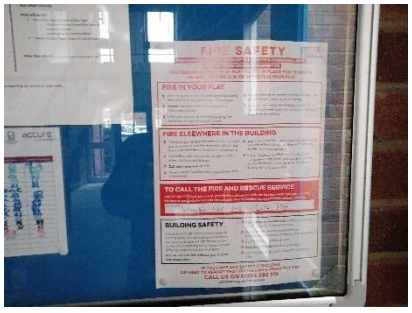
Stay Put fire action notice

“No Smoking” signage	
No signage on entry door

Hazard: Fire Safety Signs and Notices	**Priority: Low**
Issue Ref: ES/86914/007	
Significant Findings: No “Keep Locked Shut” signage on doors including entry doors.	
Action Required: In line with Safety Signs and Signals Regulations 1996 - PART 3 Fire safety signs**,** “Keep Locked Shut” sign to be fitted to entry door.
