FIRE RISK ASSESSMENT REPORT
on behalf of Colchester Borough Homes

7-12 Willow Tree Court
Colchester
CO4 3LW

Date assessed: 13th March 2023

Project Number: 86949

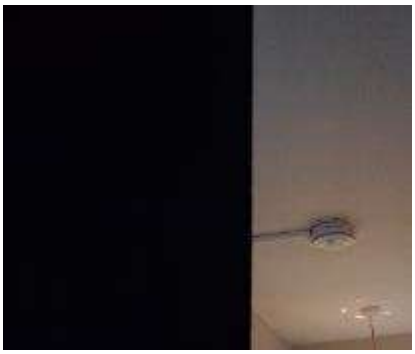
Smoke detection

There is no communal automatic fire detection on the premises as per guidance outlined in Local Government Association - Fire Safety in Purpose Built Flats, Section 20.4: *'*. In 'general needs' blocks designed to support a 'stay put' policy, it is unnecessary and undesirable for a fire alarm system to be provided. A communal fire detection and alarm system will inevitably lead to a proliferation of false alarms. This will impose a burden on fire and rescue services and lead to residents ignoring warnings of genuine fires.' there was however, LD3 smoke detection within the hallway of the flats. This is taken from sampled flat 7.
