FIRE RISK ASSESSMENT REPORT
on behalf of Colchester Borough Homes

97A-D Winnock Road
Colchester
CO1 2BQ

Date assessed: 22nd February 2023

Project Number: 86214

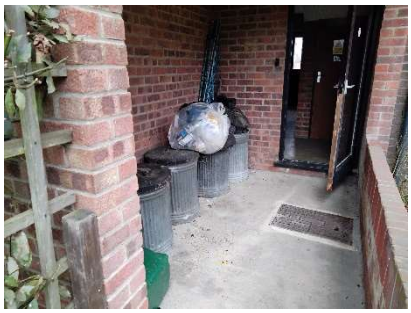
Hazard: Arson	**Priority: Low**
Issue Ref: ES/86214/001	
Significant Findings: The rear door does not fully close into frame and lock of its own accord.	
Action Required: Management should employ contractor to adjust self-closing device to ensure door is fully closing into door and contact residents to advise that the common area access/egress doors to property should be kept locked at all times.

Rear door not closing

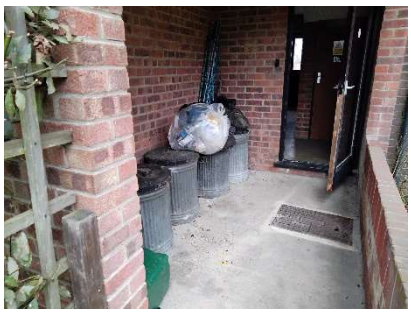
Refuse area at rear of block

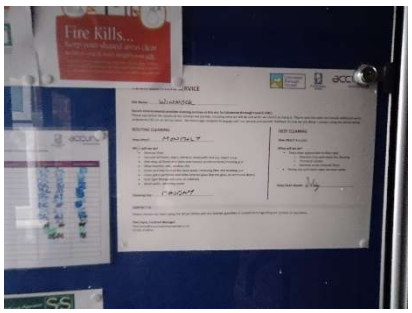
Hazard: Housekeeping	Priority: Medium
Issue Ref: ES/86214/002	
Significant Findings: There were combustible items noted within the electrical intake cupboard at the time of inspection.	
Action Required: Management should contact residents to advise that the common area/escape routes and electrical equipment cupboards should be kept free from all combustibles and/or trip hazards. A programme of regular checks should be put in place to ensure that the common area is kept clear.	
Actioned by:	**Date of Action:**
Comments Following Action:

There were combustible items noted within the electrical intake cupboard at the time of inspection.

Items on electrical cupboard	
Cleaning rota displayed on notice board
