FIRE RISK ASSESSMENT REPORT
on behalf of Colchester Borough Homes

1-6 Wisteria Court
Colchester
CO4 3QH

Date assessed: 17th March 2023

Project Number: 86984

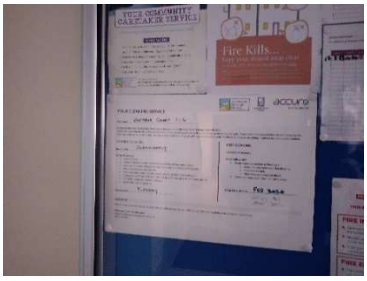
Housekeeping is of a good standard within the property and cleaning undertaken regularly, including rota displayed on notice board.

Cleaning rota

Waste bins and chutes

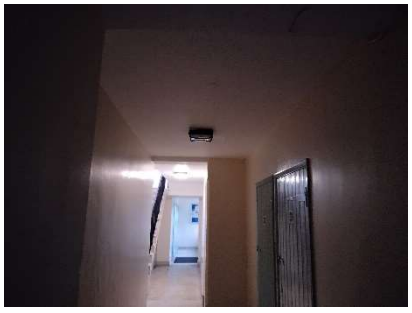
Various lights not fully operational

First and second floor openable windows

Hazard: Means of Escape	**Priority: High**
Issue Ref: ES/86984/003	
Significant Findings: Various lights within the property were not working at time of inspection.	
Action Required: Adequate artificial lighting should be provided in common escape routes, such as corridors, lobbies and stairways, to enable residents and visitors to make their way safely out of the building. Regular maintenance to be undertaken on lighting and faults to be rectified as soon as possible.	
Actioned by:	**Date of Action:**
Comments Following Action:

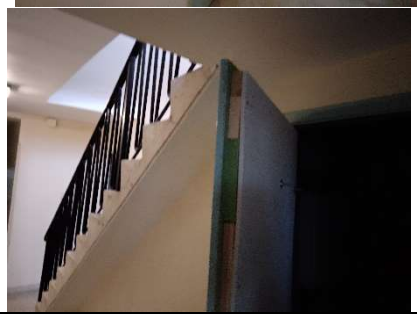
Electrical cupboard door may not be suitable to resist fire/smoke for a minimum of thirty minutes. There is damage to frame and door itself.

Unsuitable electric cupboard door

No access to roof space	
Vertically stacked balconies	
Example flat door.

Hazard: Measures to Limit Fire Spread and Development	**Priority: Low**
Issue Ref: ES/86984/004	
Significant Findings: Electrical cupboard door may not be suitable to resist fire/smoke for a minimum of thirty minutes. There is damage to frame and door itself.	
Action Required: All current personal storage cupboards should be checked for any potential ignition risks, following the assessment, doors may need to be replaced with suitable door set installations including the fixings and firestopping between the frame and the wall.	
Actioned by:	**Date of Action:**
Comments Following Action:

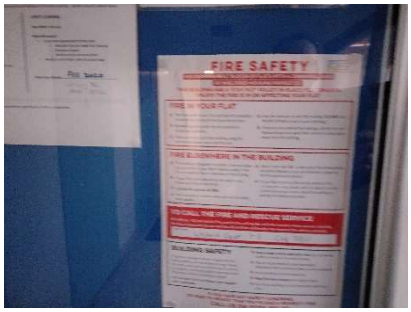
“Keep Locked Shut” and “Danger Electricity” signage on electrical intake cupboard.

Stay Put fire action notice

Signage on entry doo	
Signage on electric cupboard door
